## Management of Root Canal-Treated Teeth with File Separation and Furcal Perforation

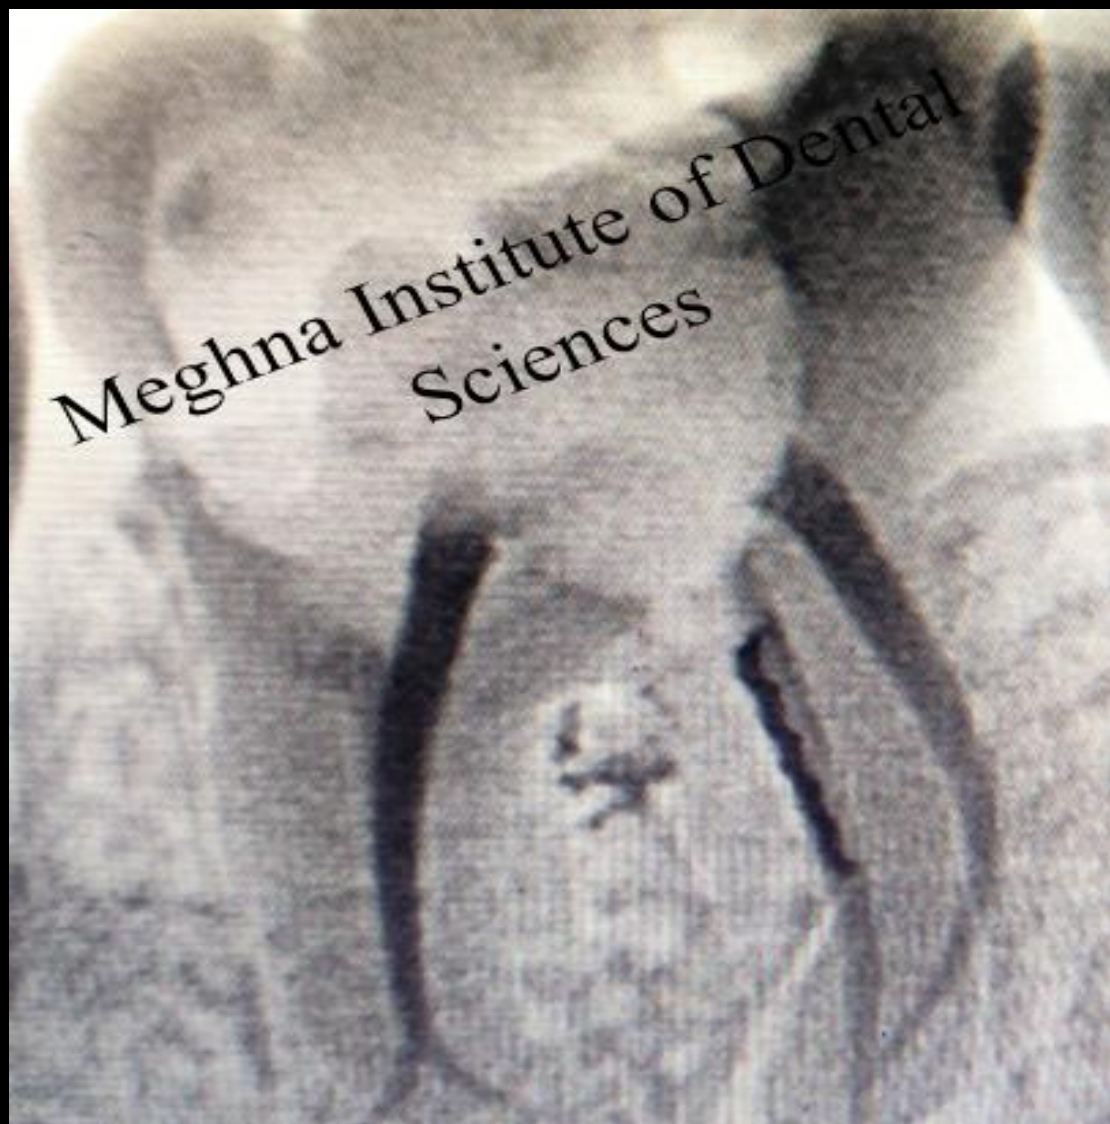
**PRE-OP RADIOGRAPHIC IMAGE IRT 46**

- Radiographic examination revealed a previously root canal–treated posterior tooth with a separated instrument fragment within the root canal, and radiolucency in the furcation region suggestive of furcal perforation.

- Based on the clinical and radiographic findings, a diagnosis of previously **Root canal-treated tooth with symptomatic apical periodontitis, complicated by iatrogenic furcal perforation and a separated endodontic instrument**” was made.
- After establishing adequate access and creating space around the coronal aspect of the fragment, H-files were introduced alongside of the separated fragment. Three H-files were engaged around the fragment and gently braided to obtain a mechanical grip. The braided files were then withdrawn coronally with the separated instrument. Complete retrieval was confirmed clinically and radiographically.

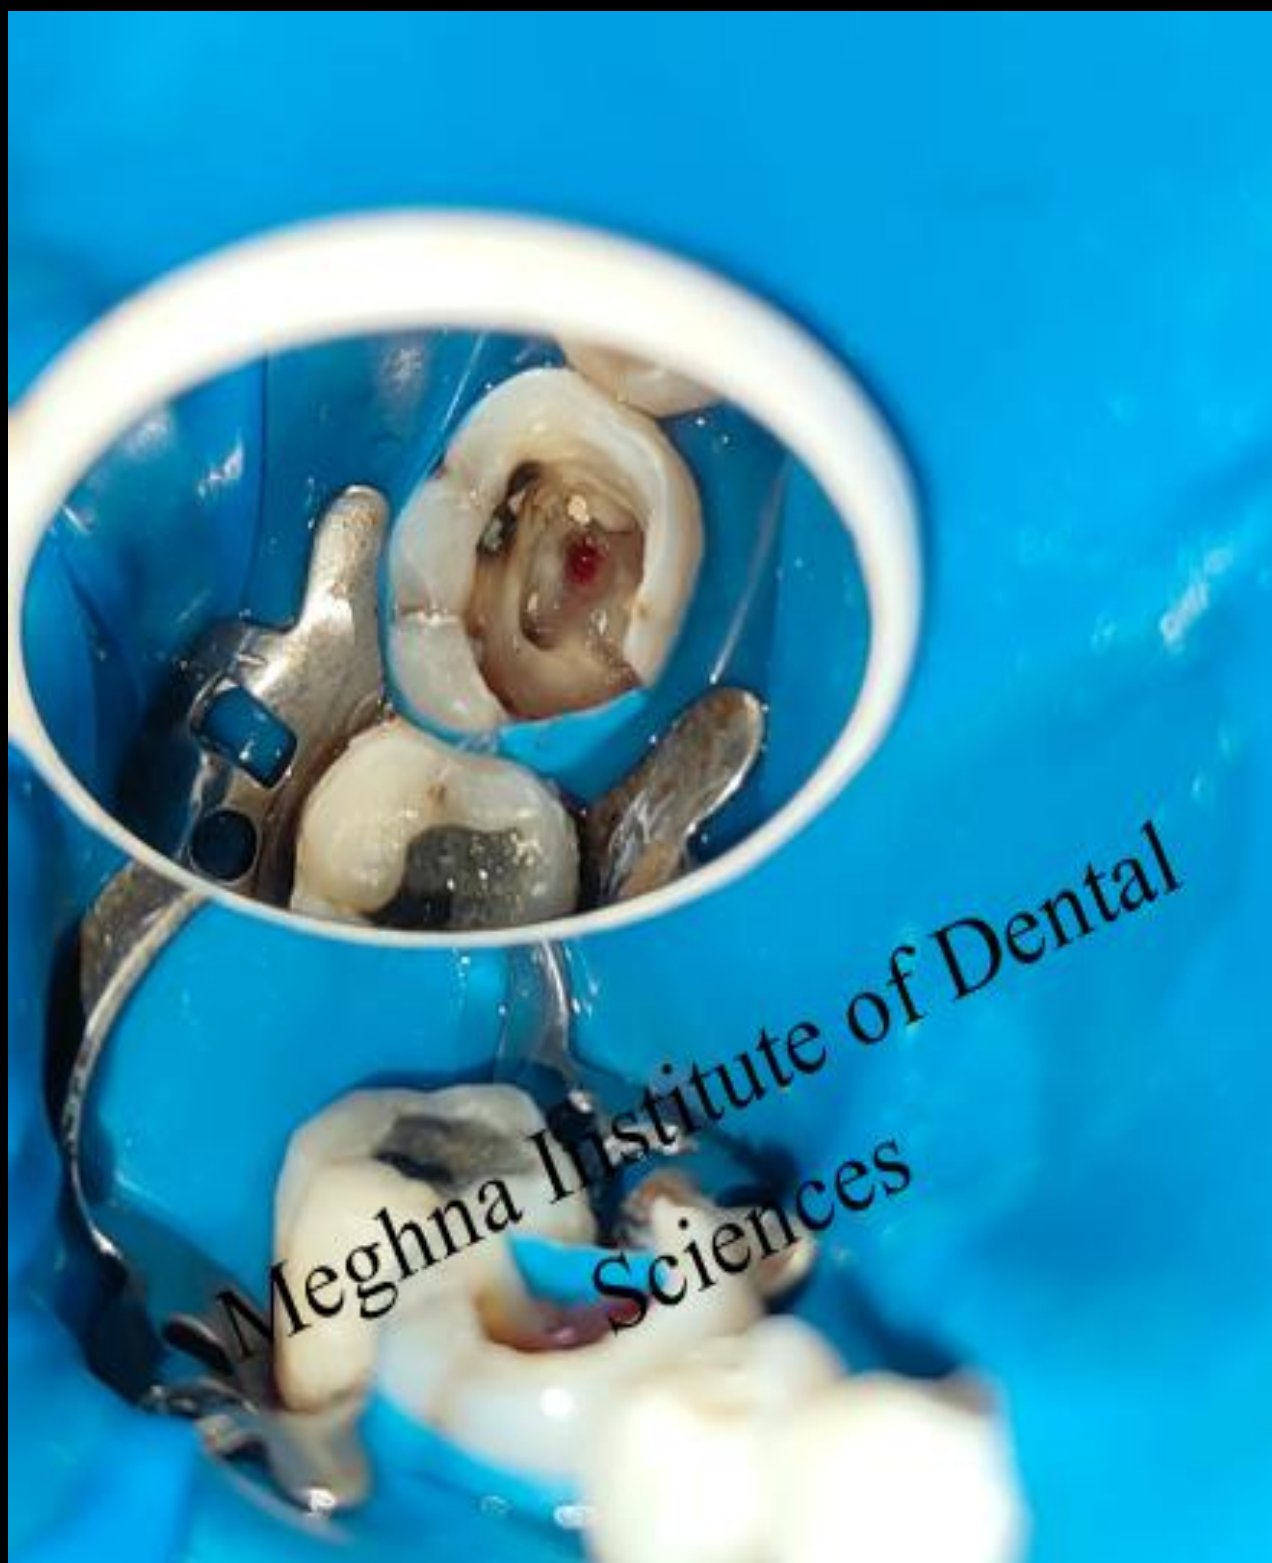
Iatrogenic furcation perforation was identified and isolated. The perforation site was thoroughly irrigated and disinfected, followed by achievement of hemostasis. MTA Putty was delivered to the furcation perforation site and gently adapted and condensed using suitable pluggers. Adequate adaptation of the MTA Putty and sealing of the furcation perforation were confirmed clinically and Radiographically.

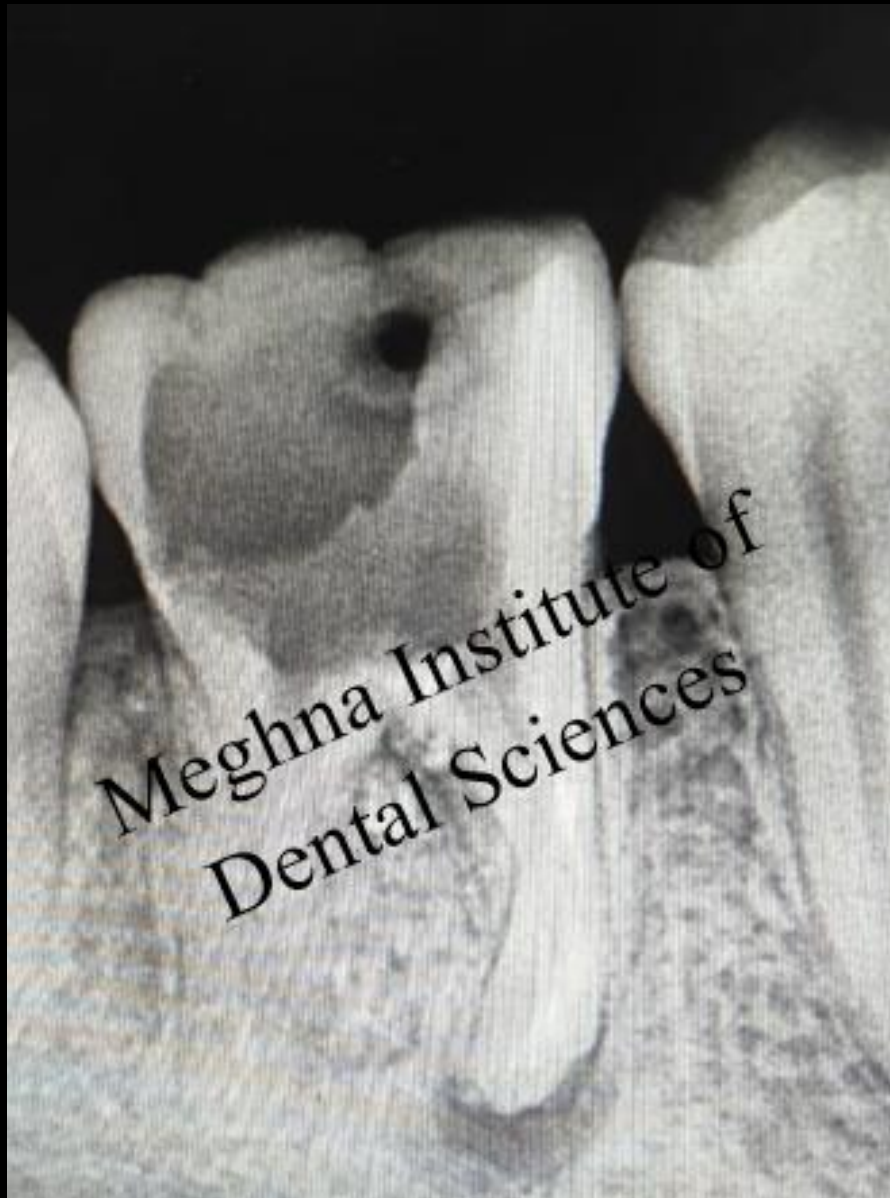
Following repair of the iatrogenic furcation perforation with MTA Putty, the root canal was re-entered, and gutta-percha was removed using appropriate rotary retreatment files. The canals were subsequently cleaned and shaped.
